Situation Photo Log

Tuesday, March 20, 2012

Kalamazoo River / Enbridge Spill

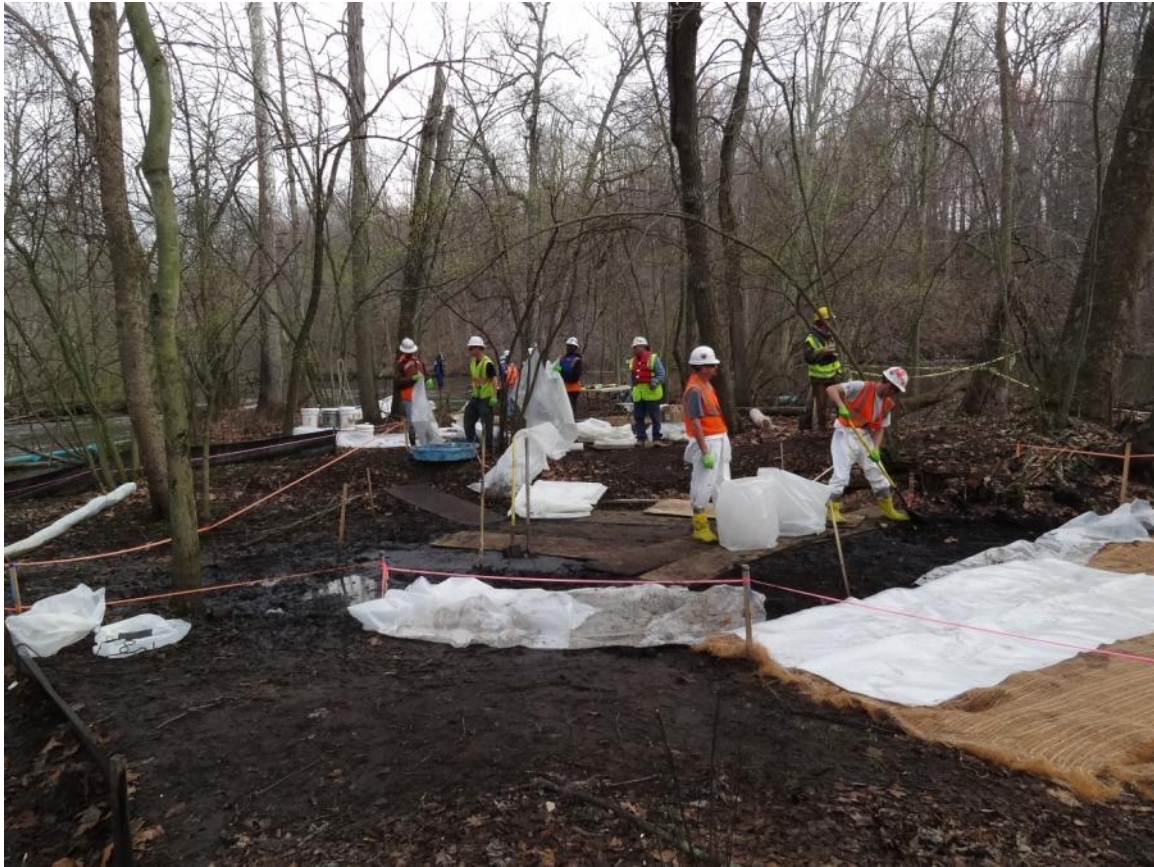
1. OB8.97 I soil scrape continues.

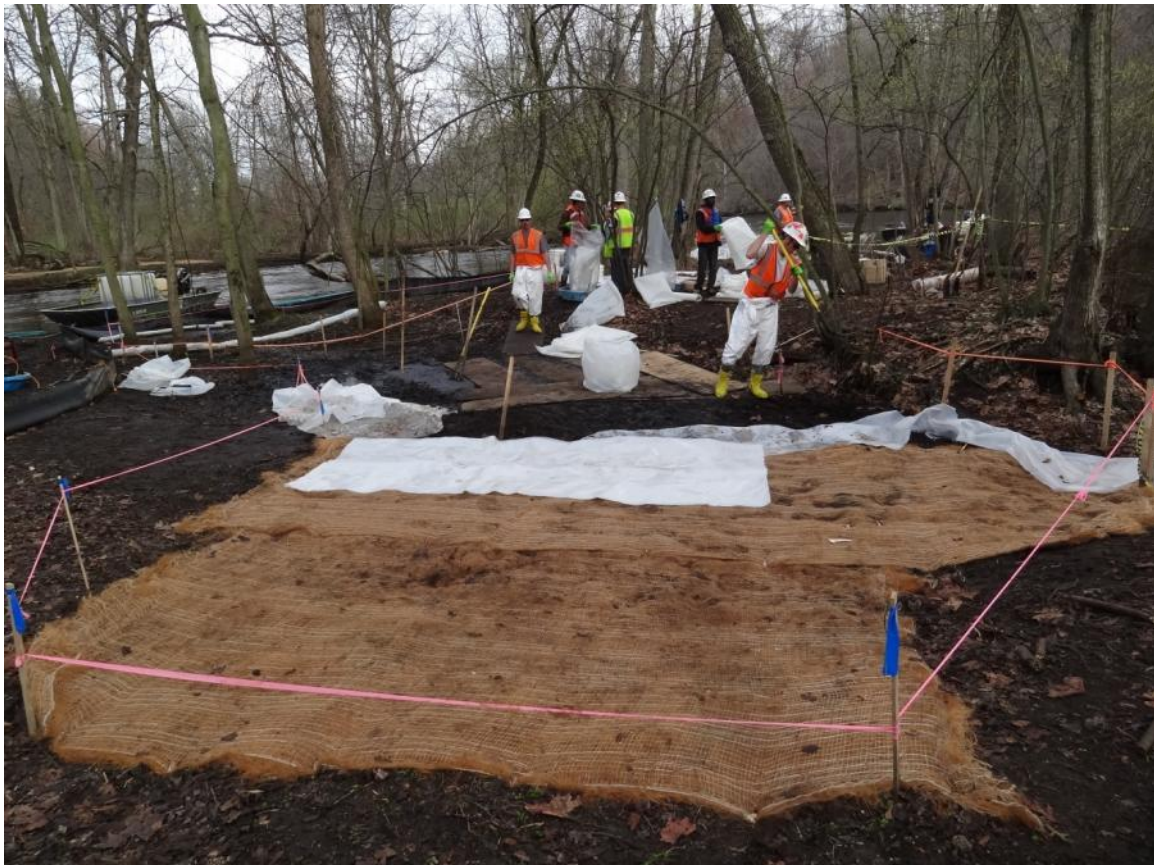
2. OB8.97 I soil scrape continues.

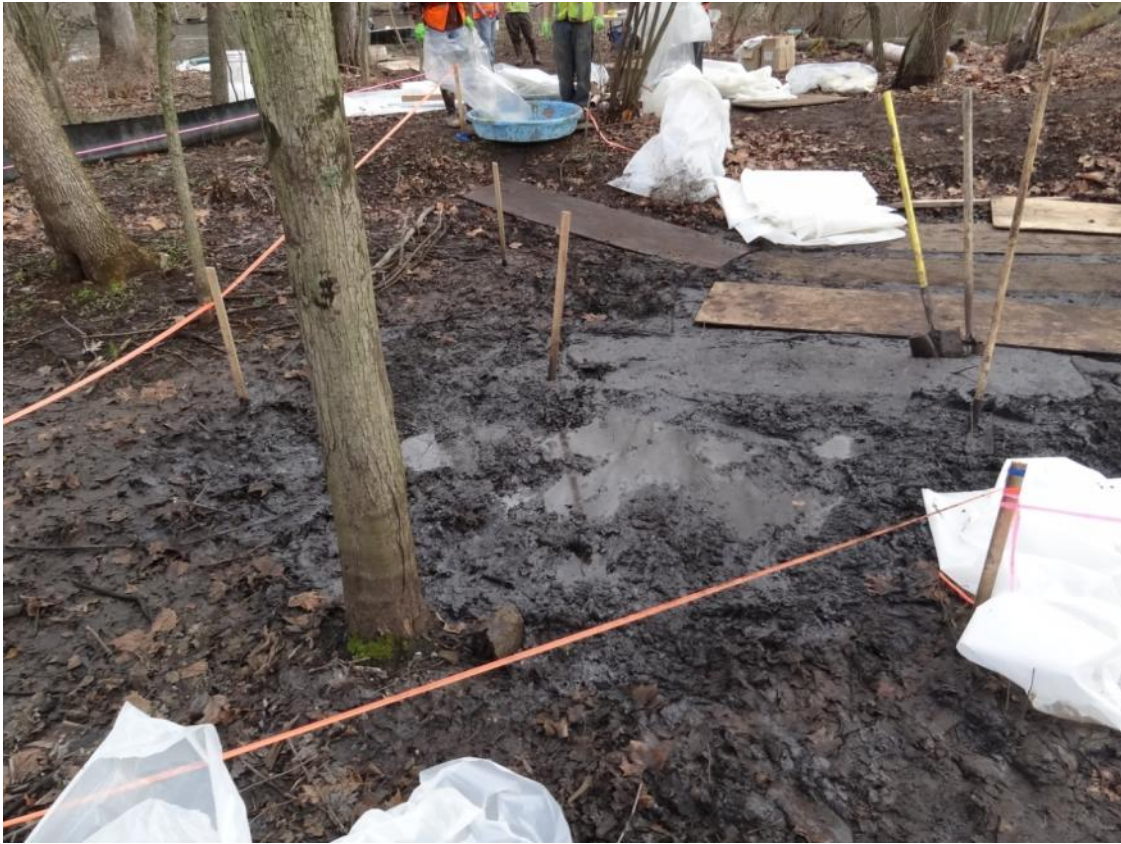
3. OB8.97 I soil dewatering of scrape area.

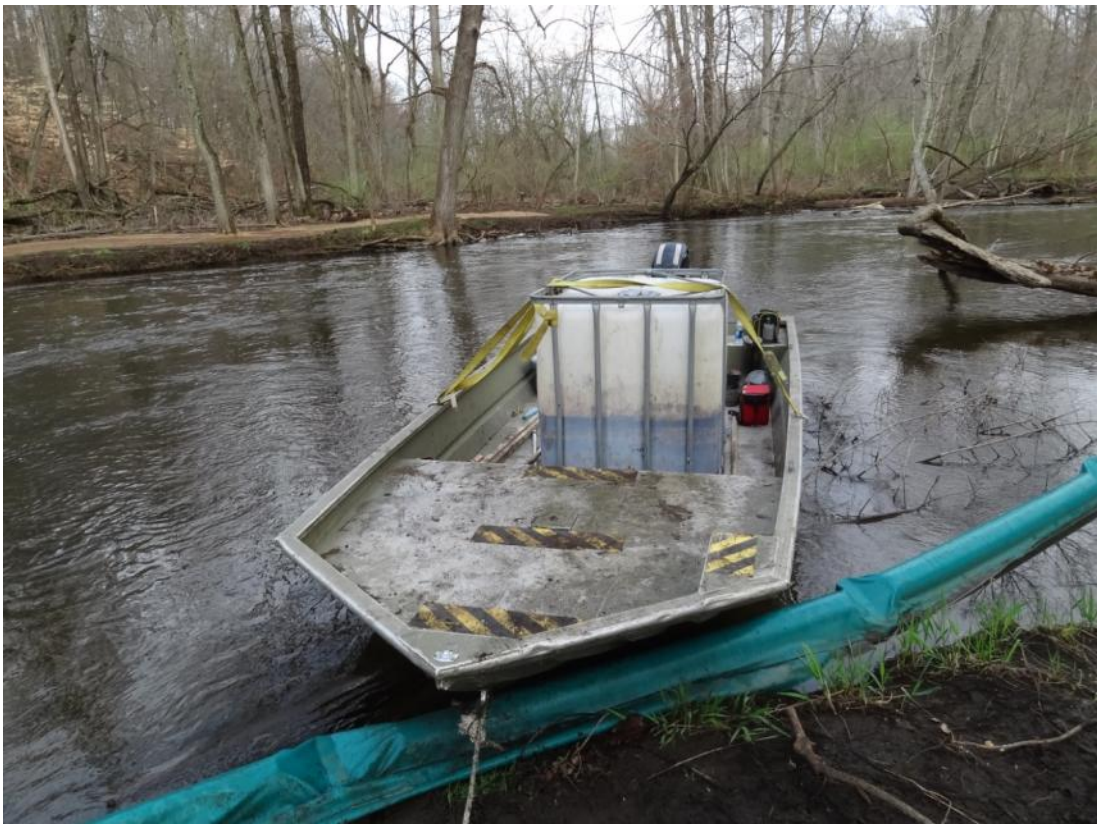
4. OB8.97 I soil tote utilized for scrape dewatering.

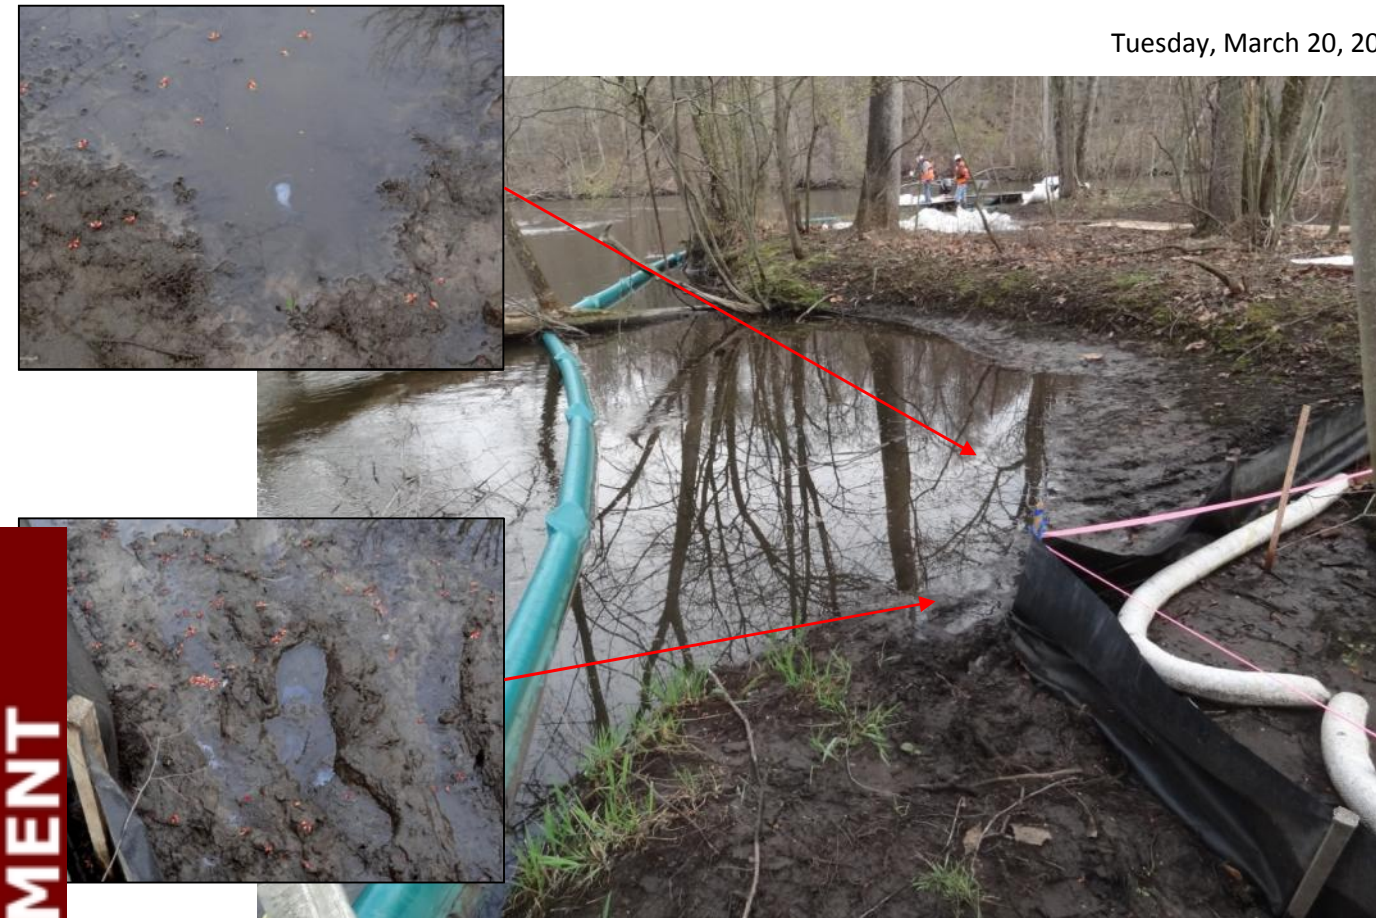
5. OB8.97 I sheen observed in boomed off area.

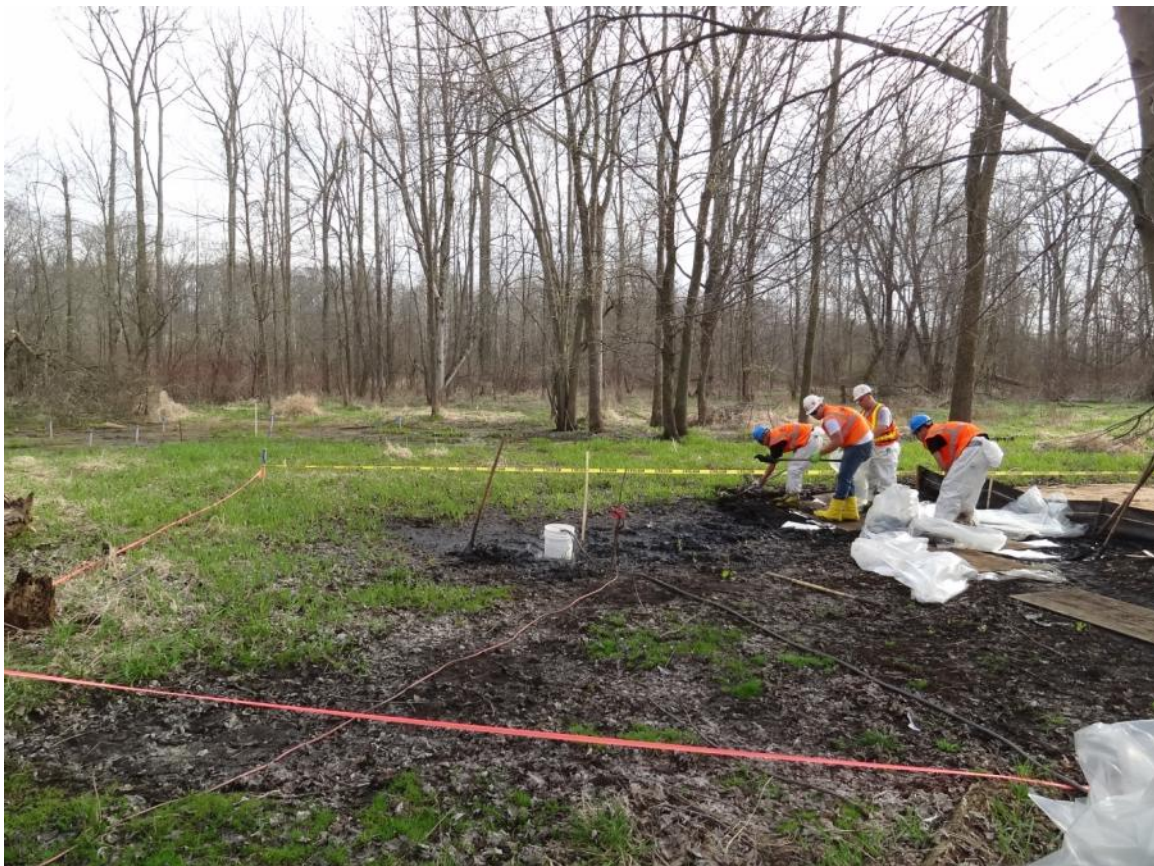
6. OB10.37RDB scrape work.

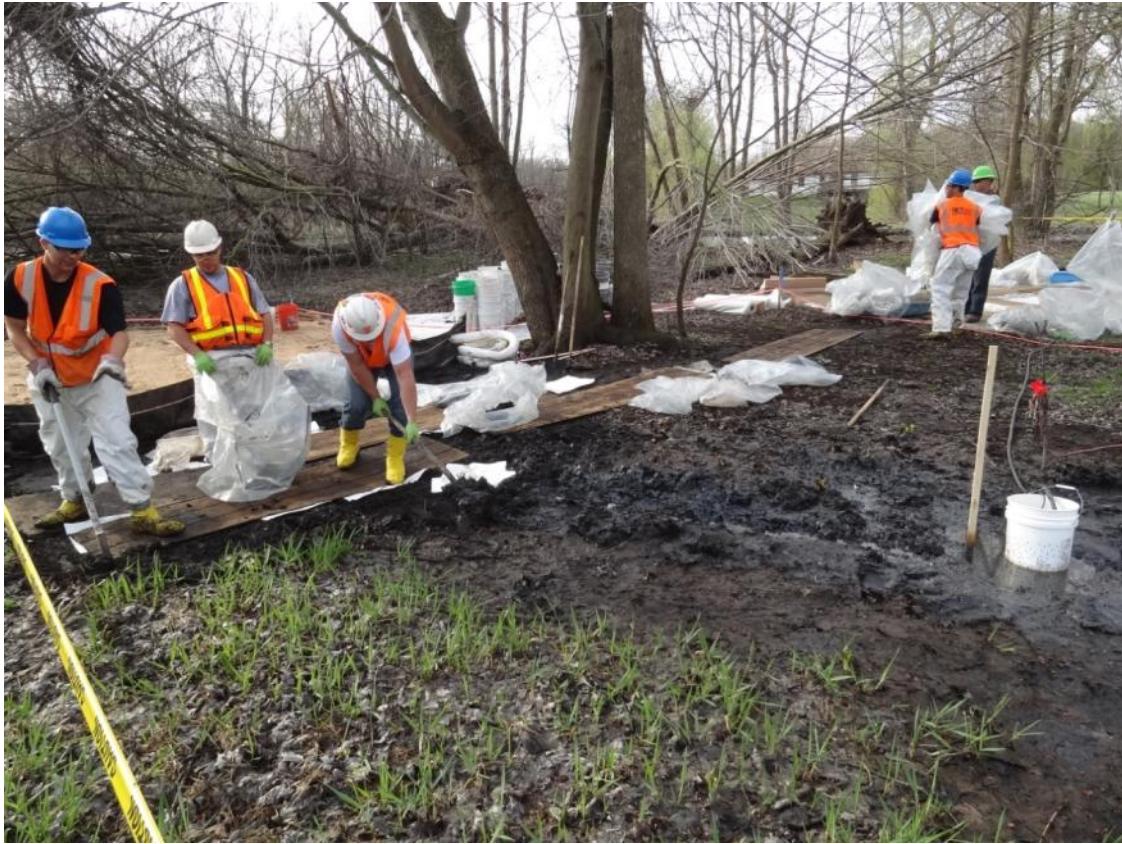
7. OB10.37RDB scrape work.

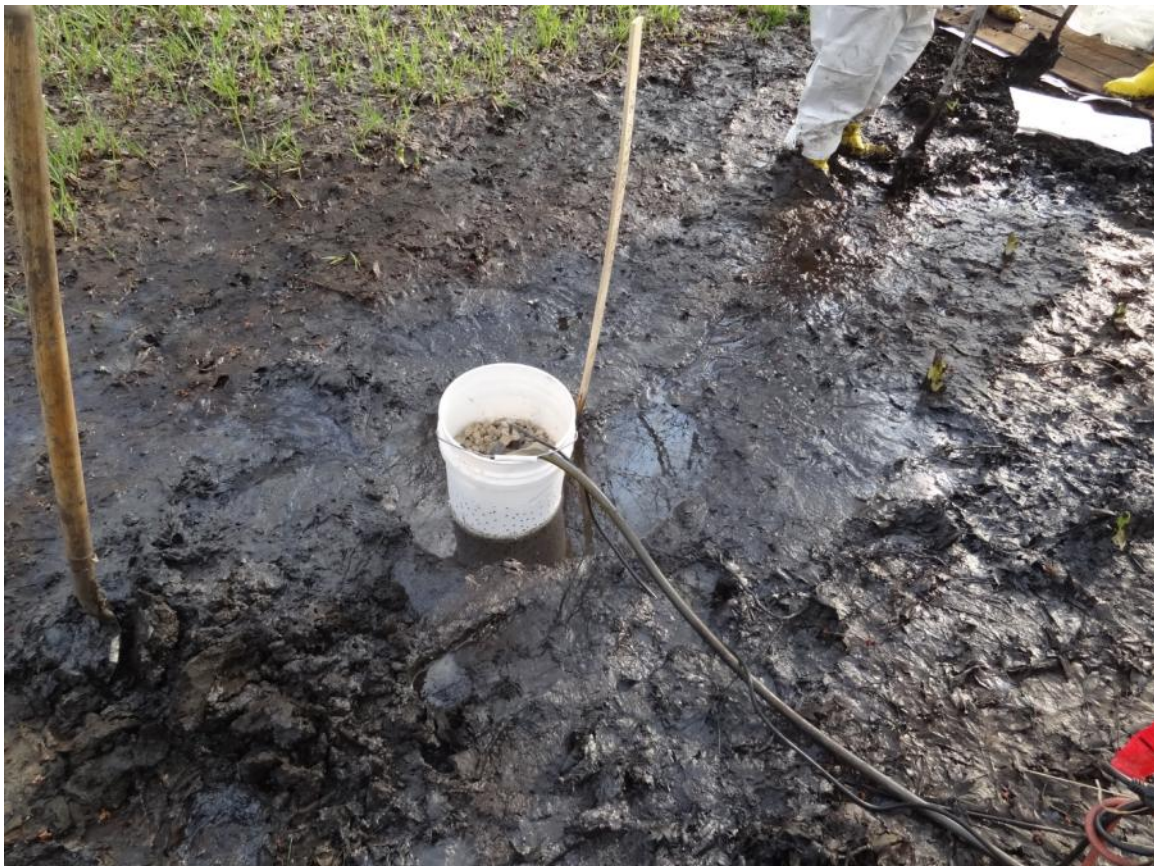
8. OB10.37RDB dewatering of scrape area.

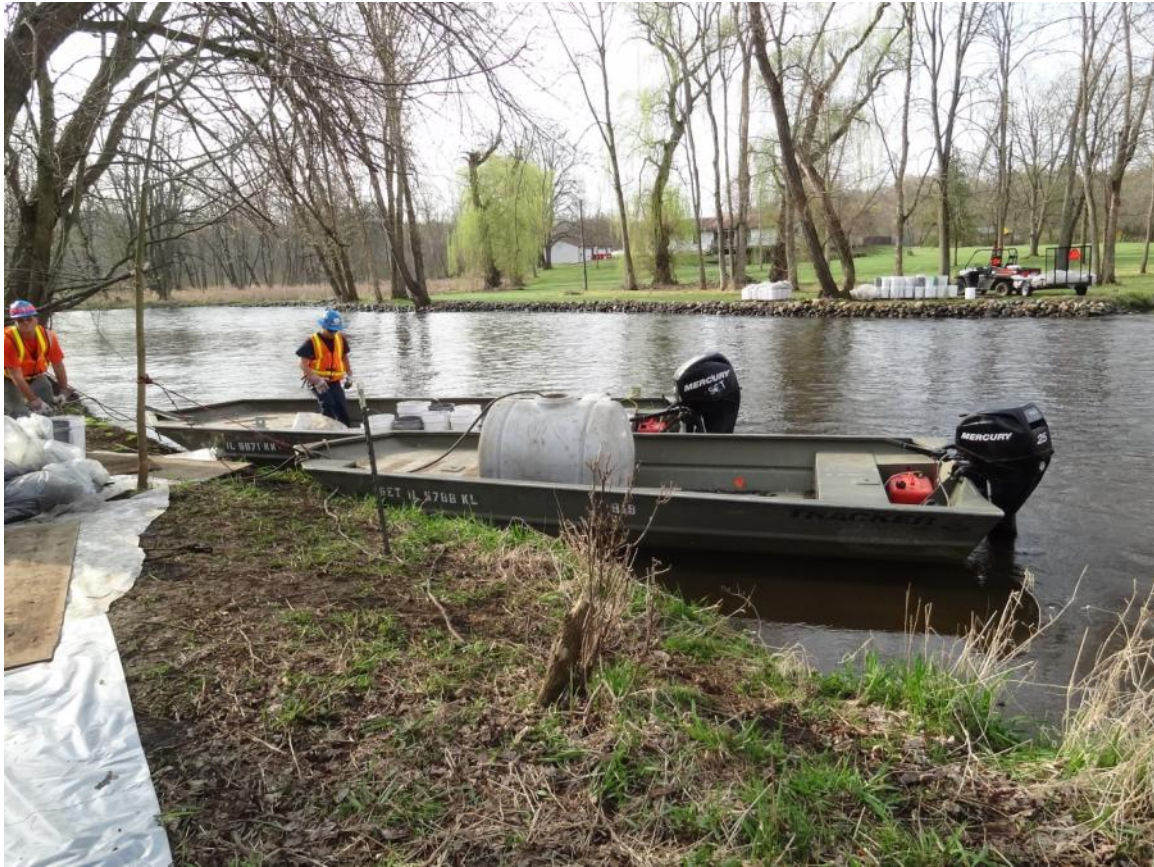
9. OB10.37RDB dewatering of scrape area into tank on boat.

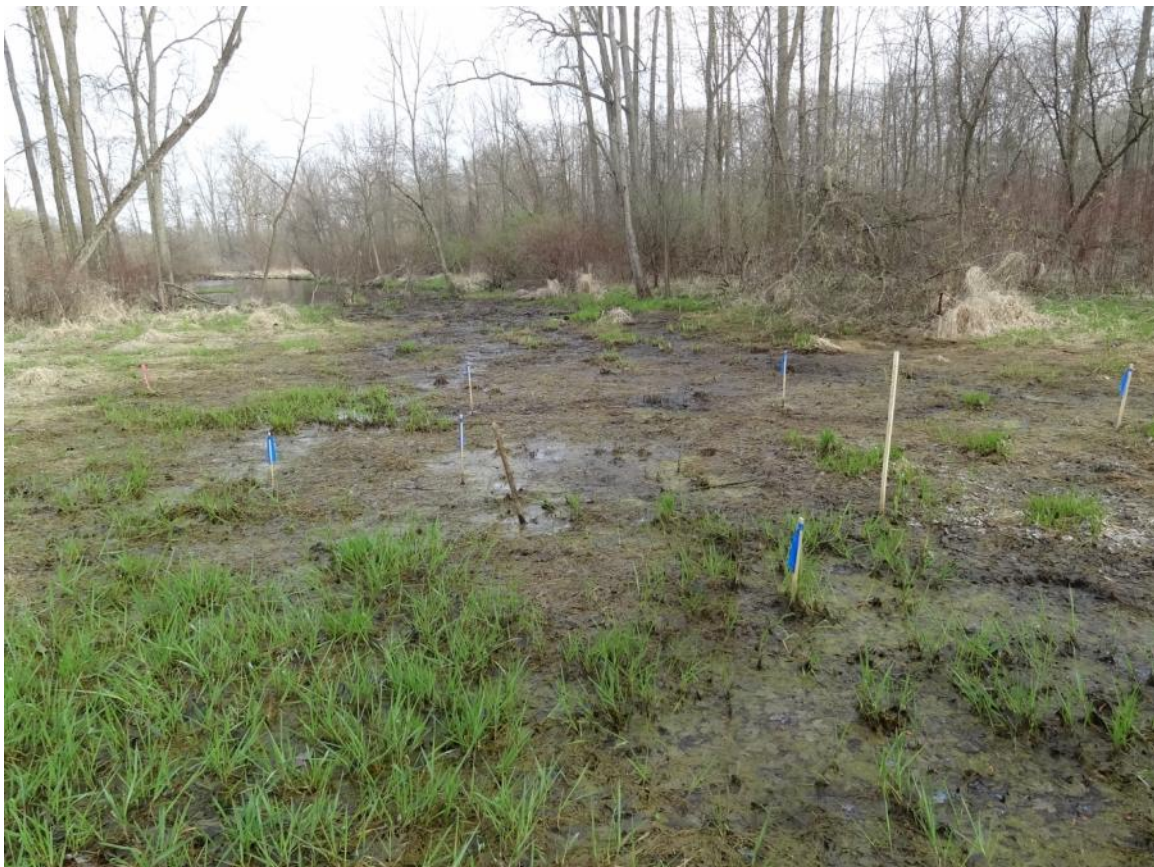
10. OB10.37RDB scrape area saturated.

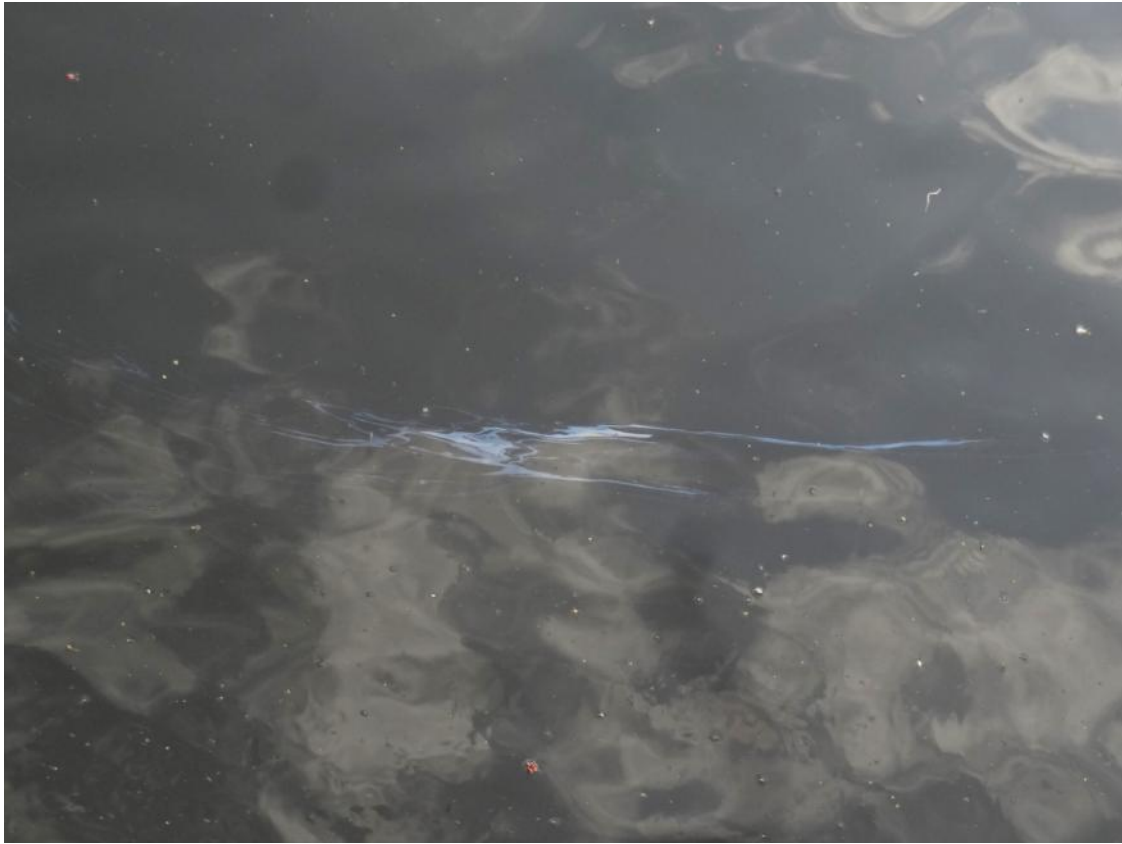
11. Ceresco Dam sheen observed going over spillway.

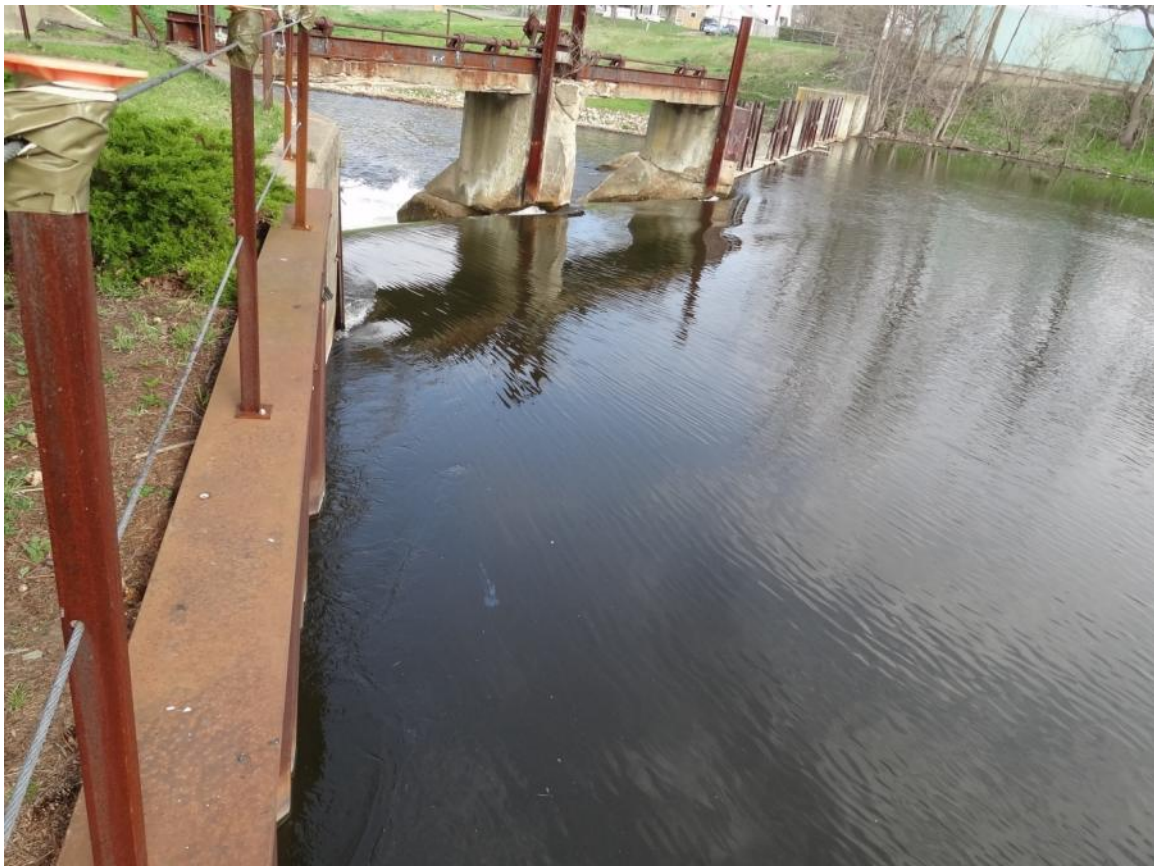
12. Ceresco Dam sheen observed going over spillway.

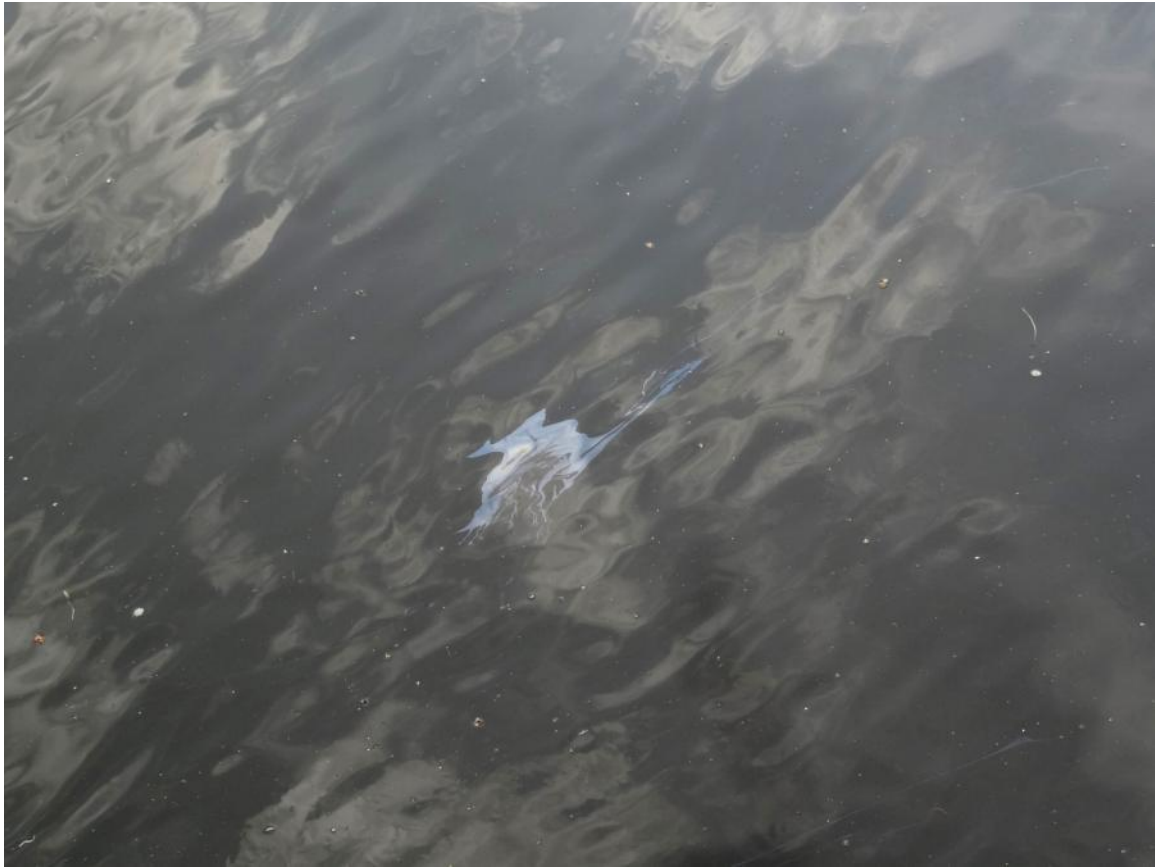
13. Ceresco Dam sheen observed going over spillway.

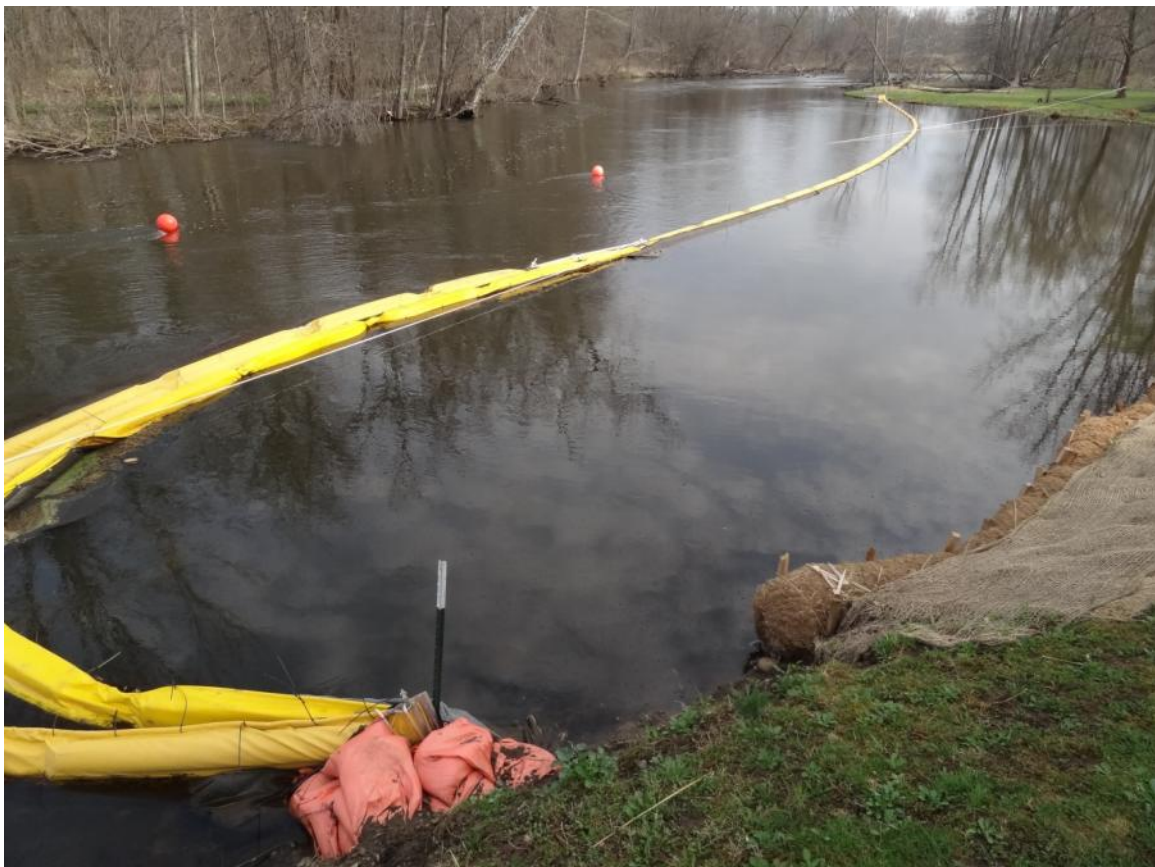
14. Confluence no sheen or sediment observed.

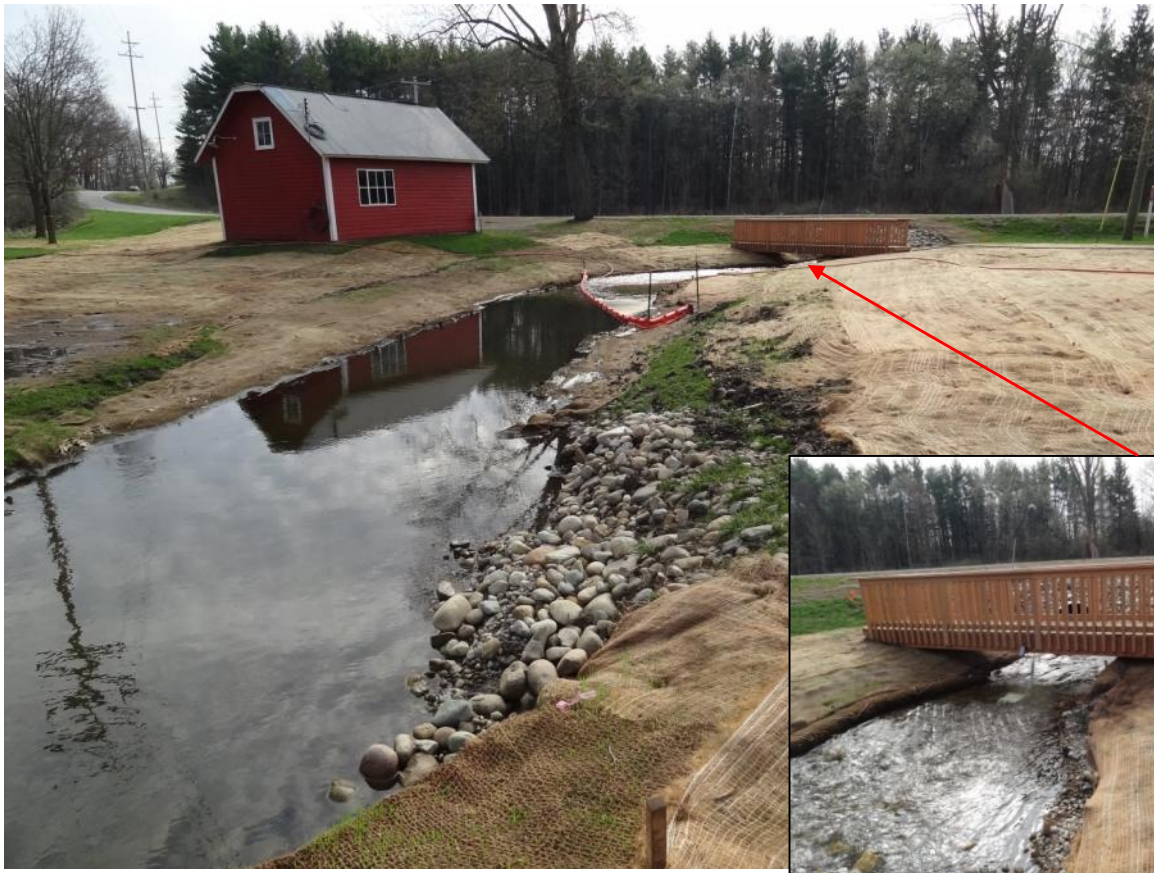
15. Talmadge Creek newly installed bridge with turbidity monitoring.

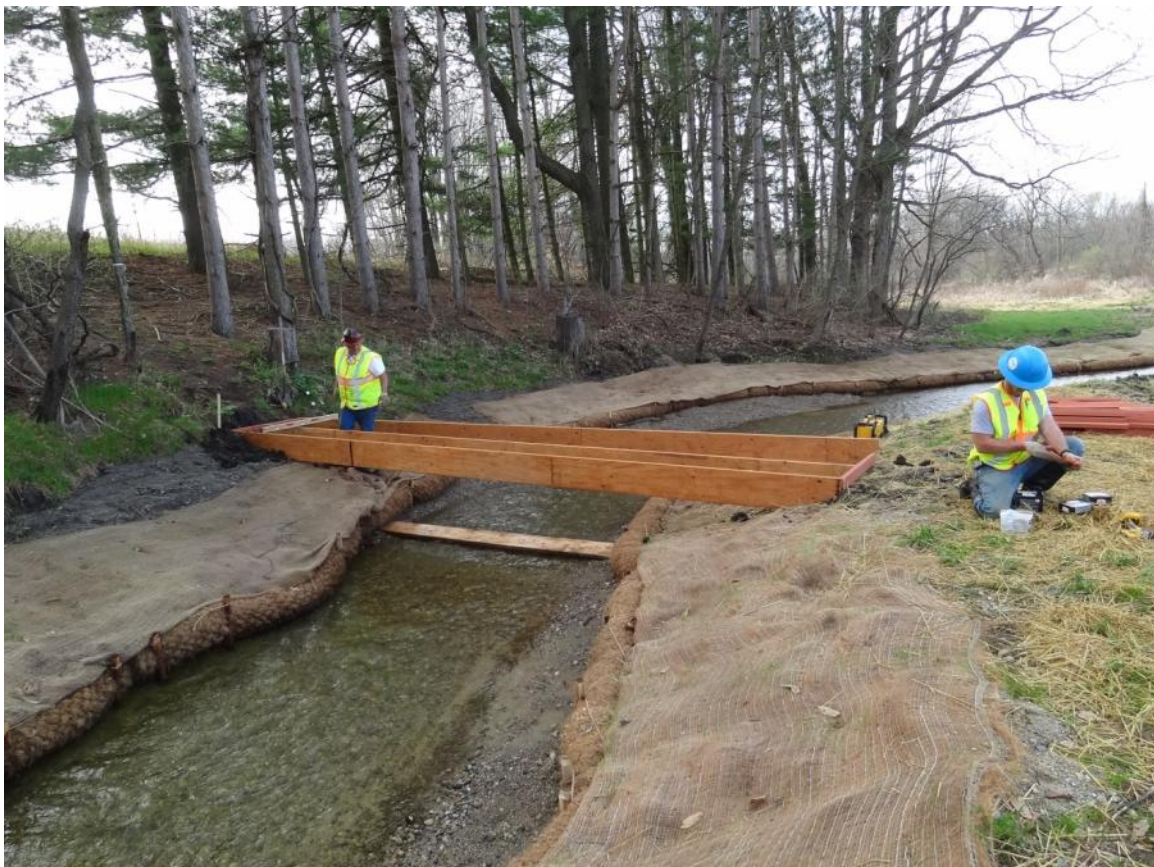
16. Talmadge Creek crews observed installing new bridge.

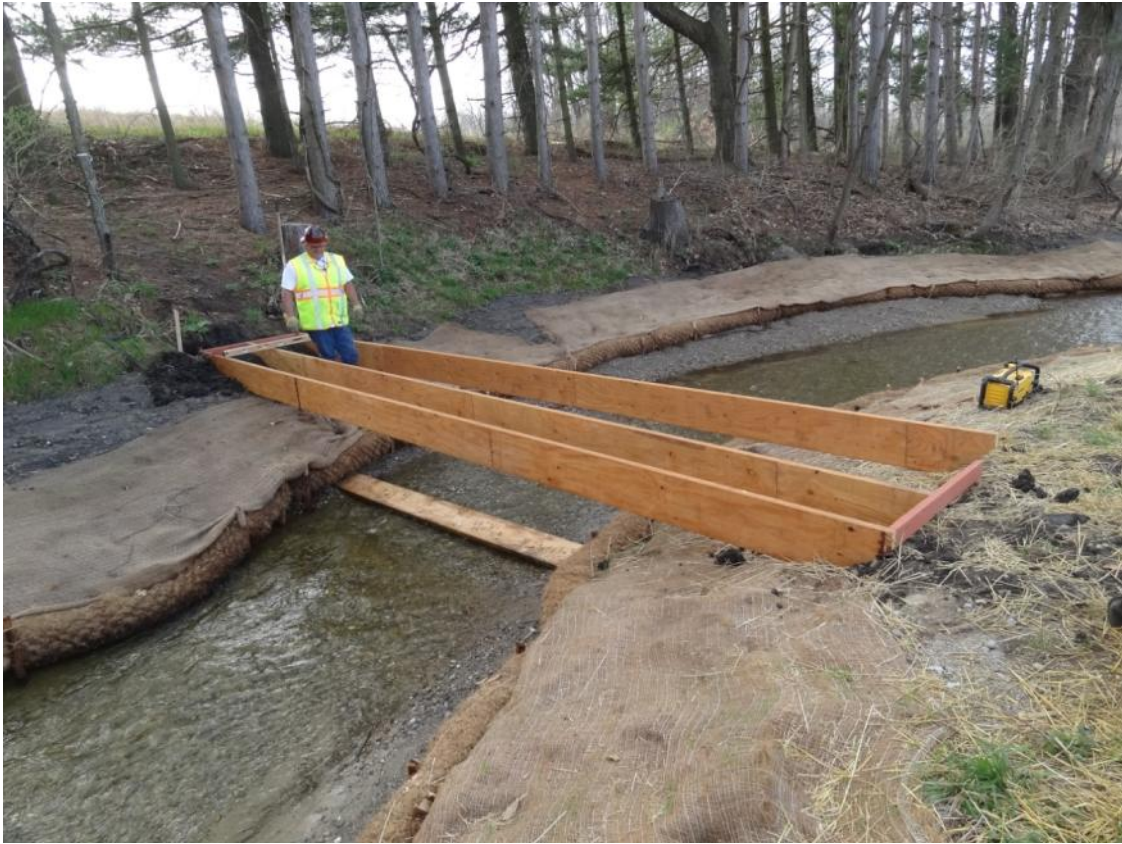
17. Talmadge Creek crews utilizing board to walk across to minimize disturbance to the creek bottom.

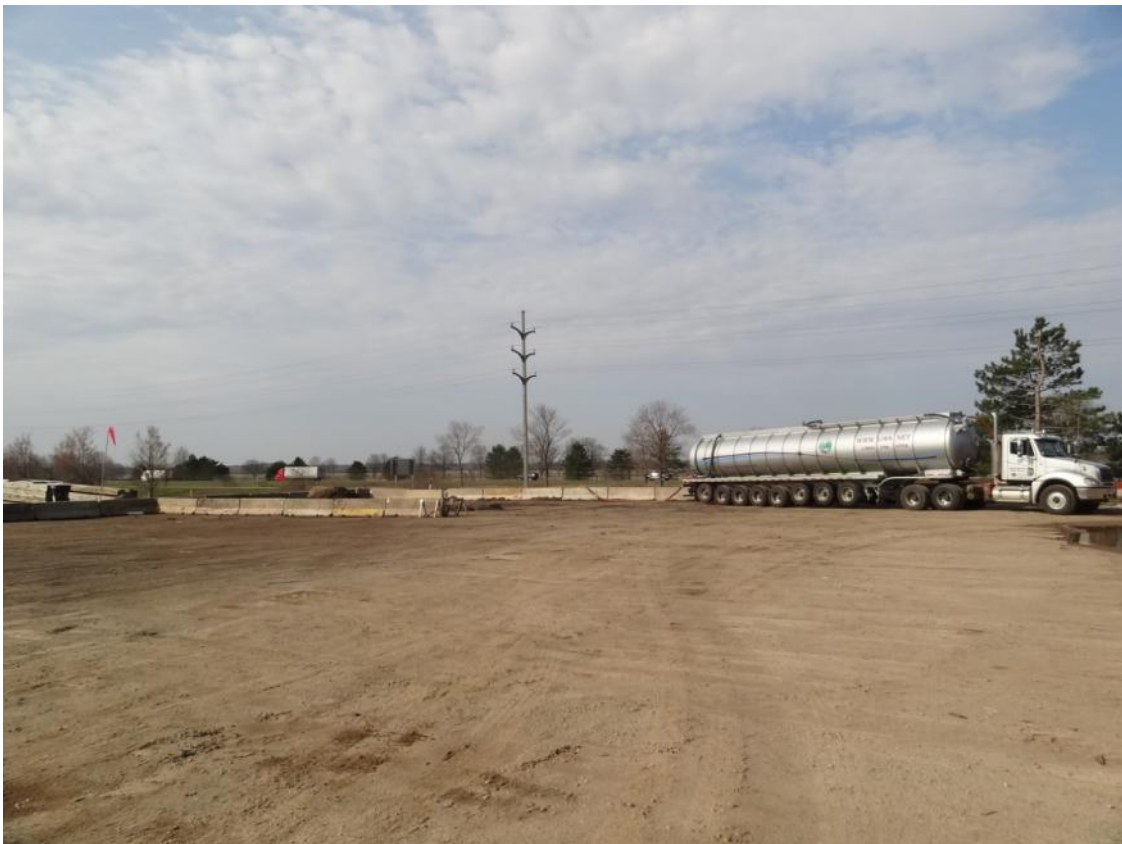
18. Frac-City truck observed draining Cells A & B sump.

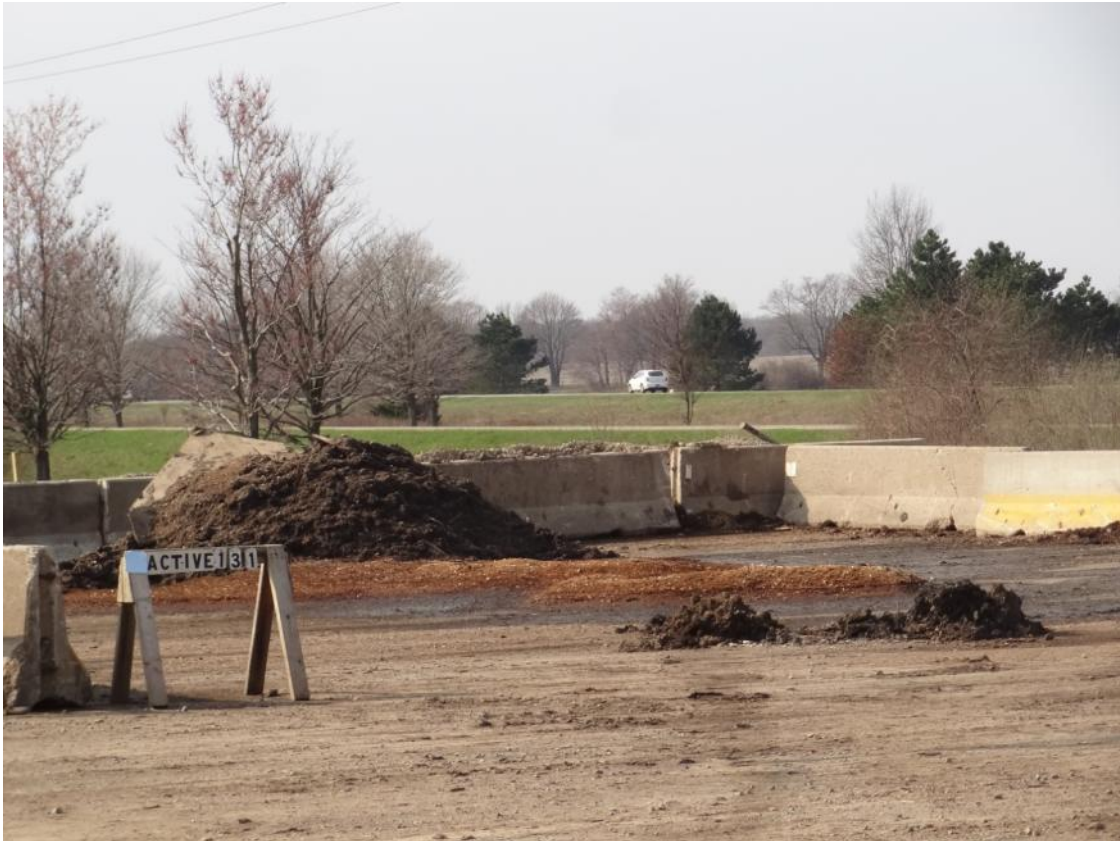
19. Frac-City Cell B soils remaining on site.

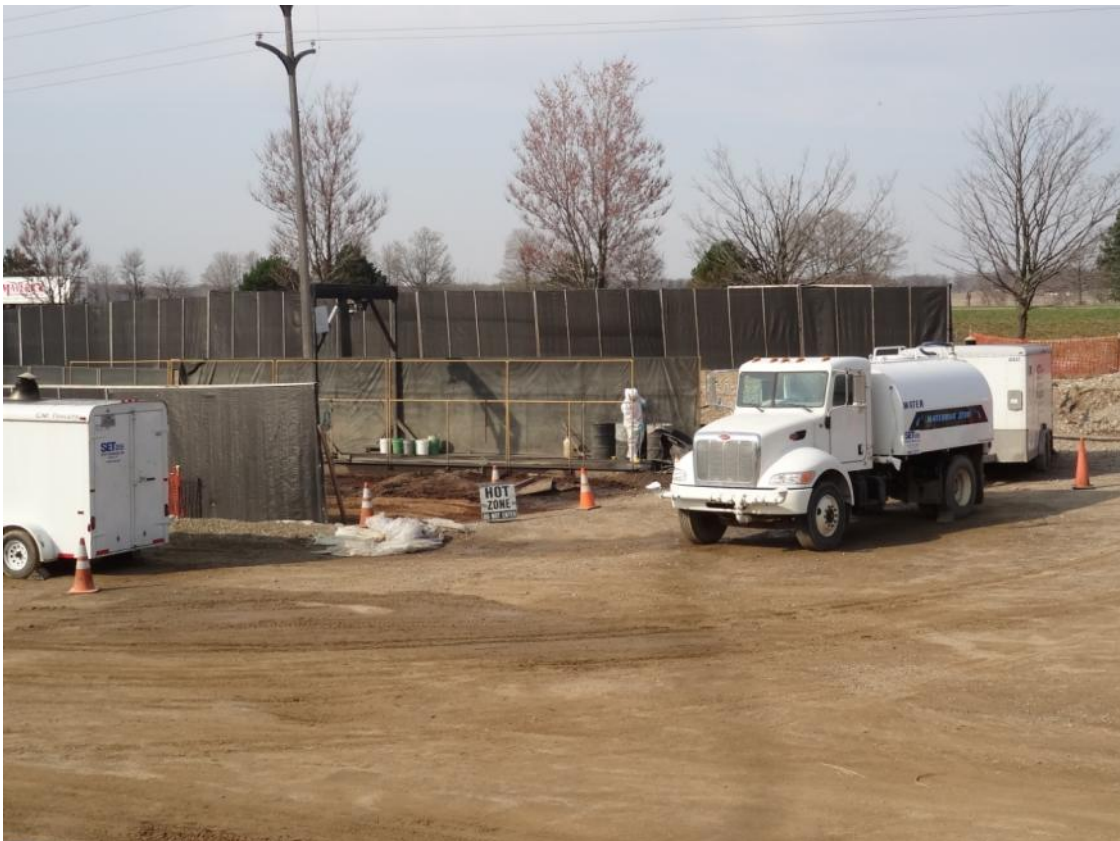
20. Frac-City decontamination work.

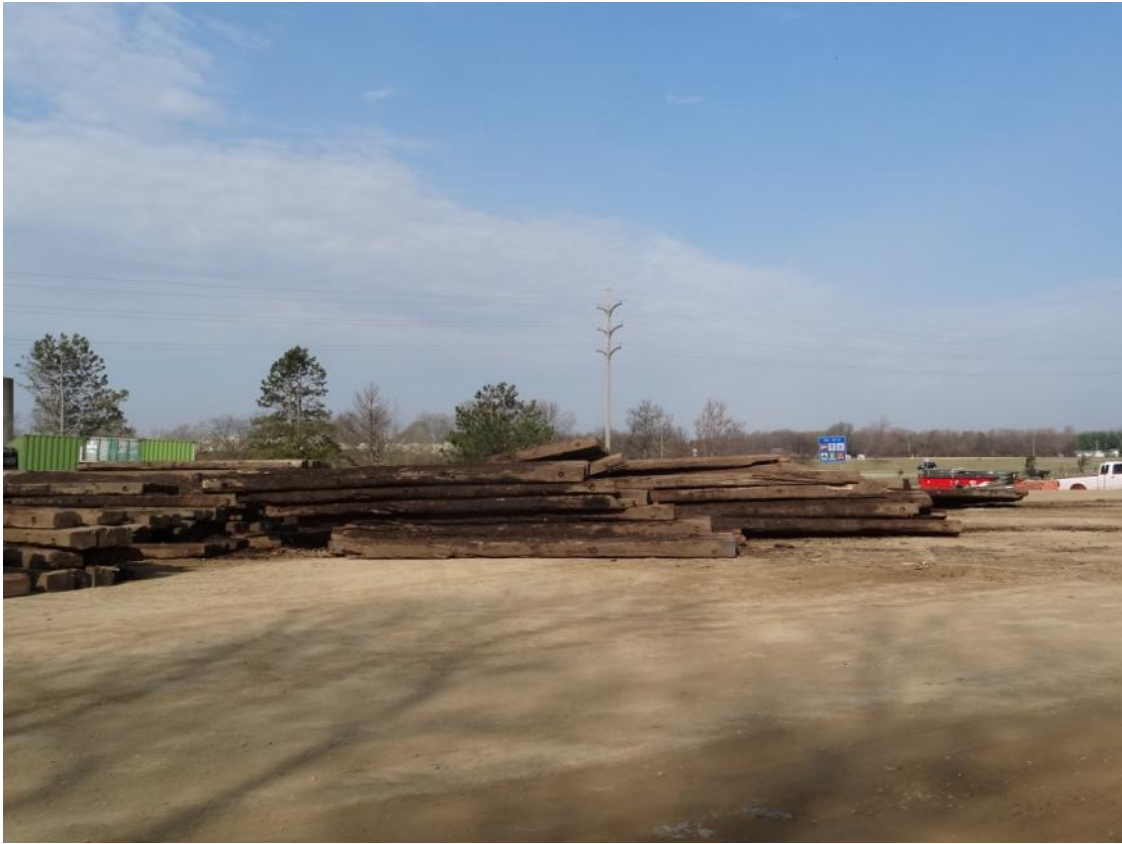
21. Frac-City timber mats stacked.

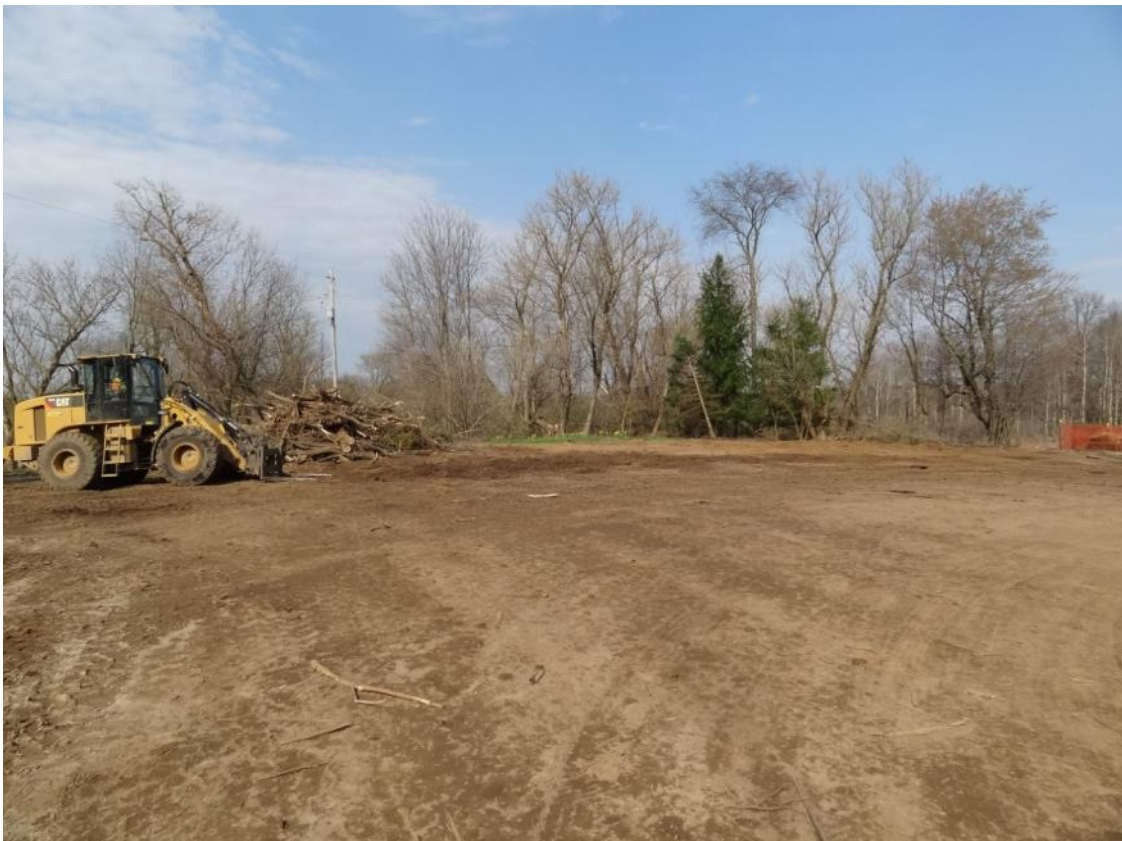
22. Timber mats have been demobilized from the haunted house location.

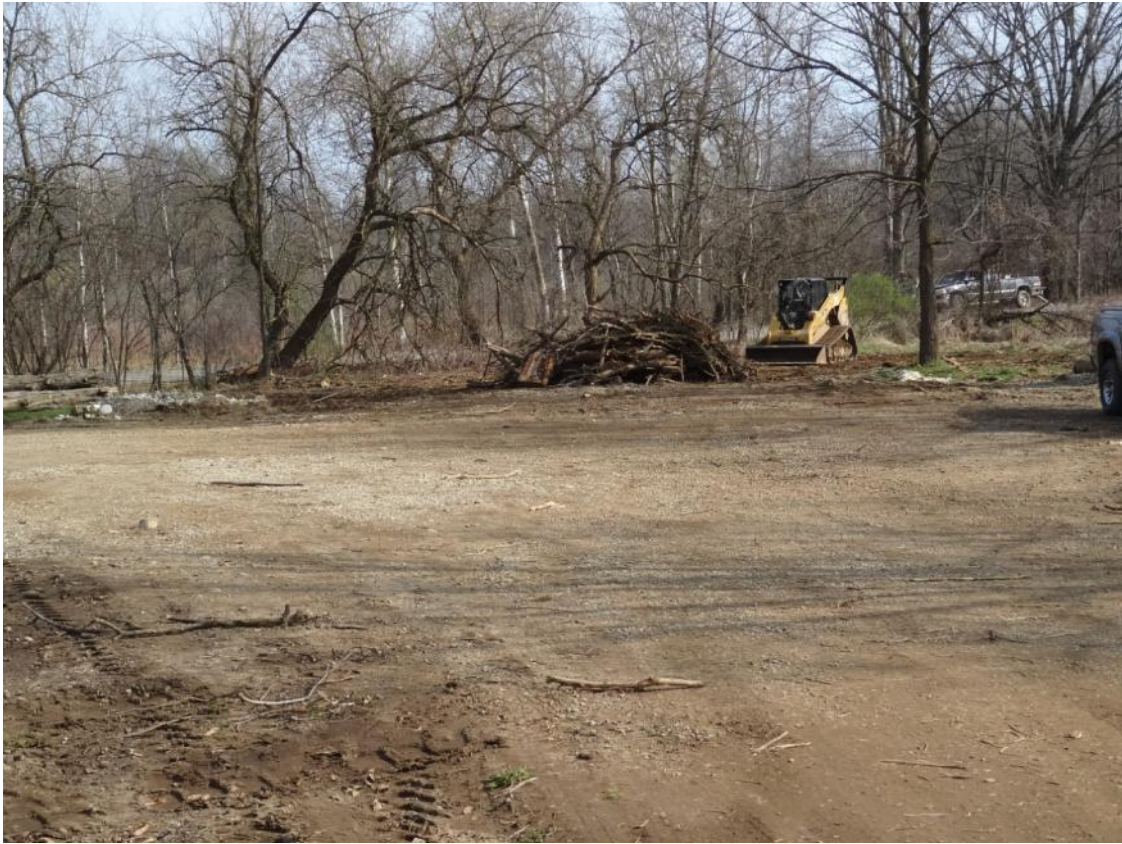
23. Demobilizing of staging area at the haunted house.
